LITTLE GOOSE DAM TANK INSPECTION REPORT

Project: LITTLE GOOSE DAM; SP001TANK INSPECTION

Report No.: 13079

PROJECT: LITTLE GOOSE DAM; SP001 TANK INSPECTION

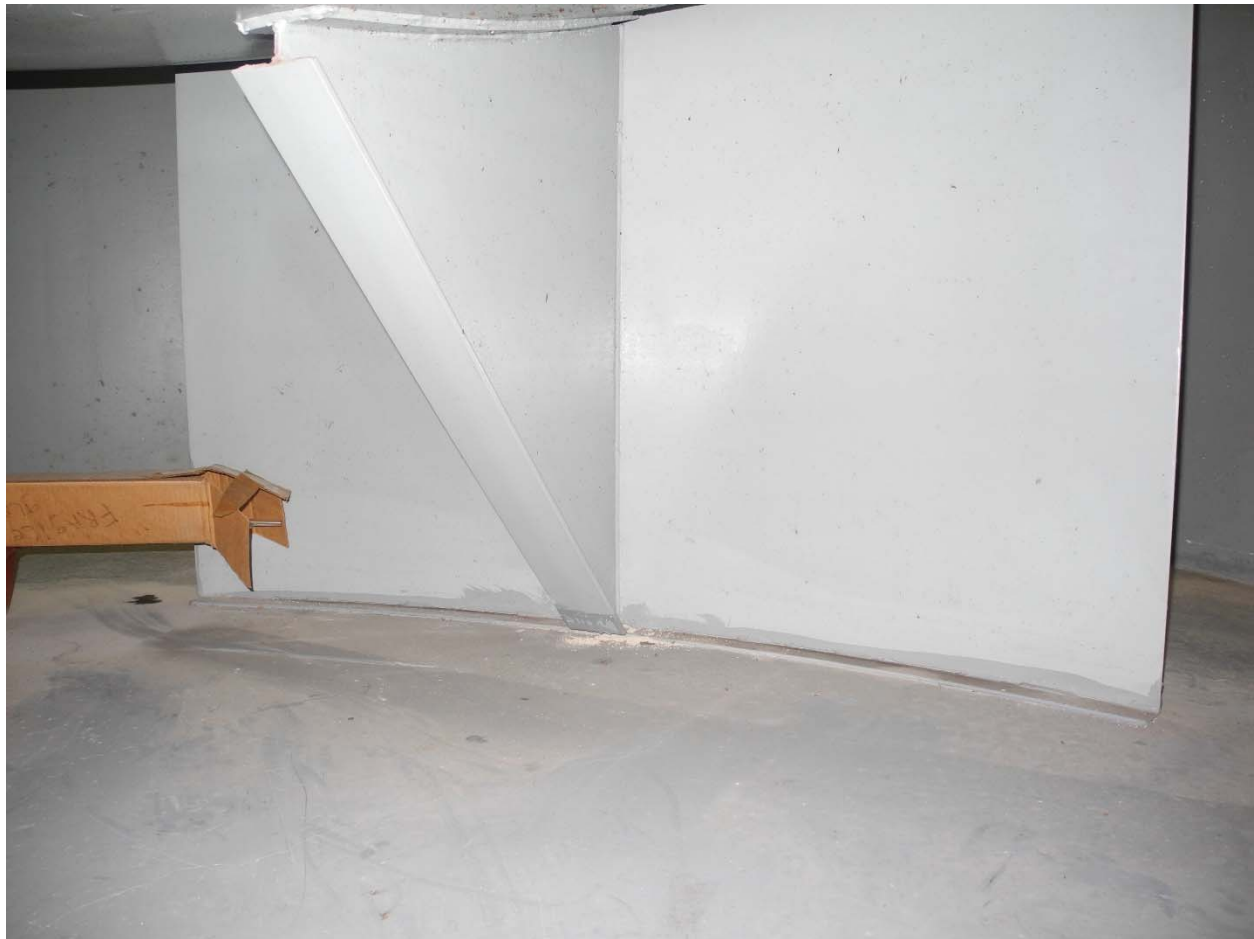
This photograph shows the one of the tank supports. Each tank has four of these supports. These supports are bearing on the oil storage room floor and are not fastened down. These tanks should be secured.

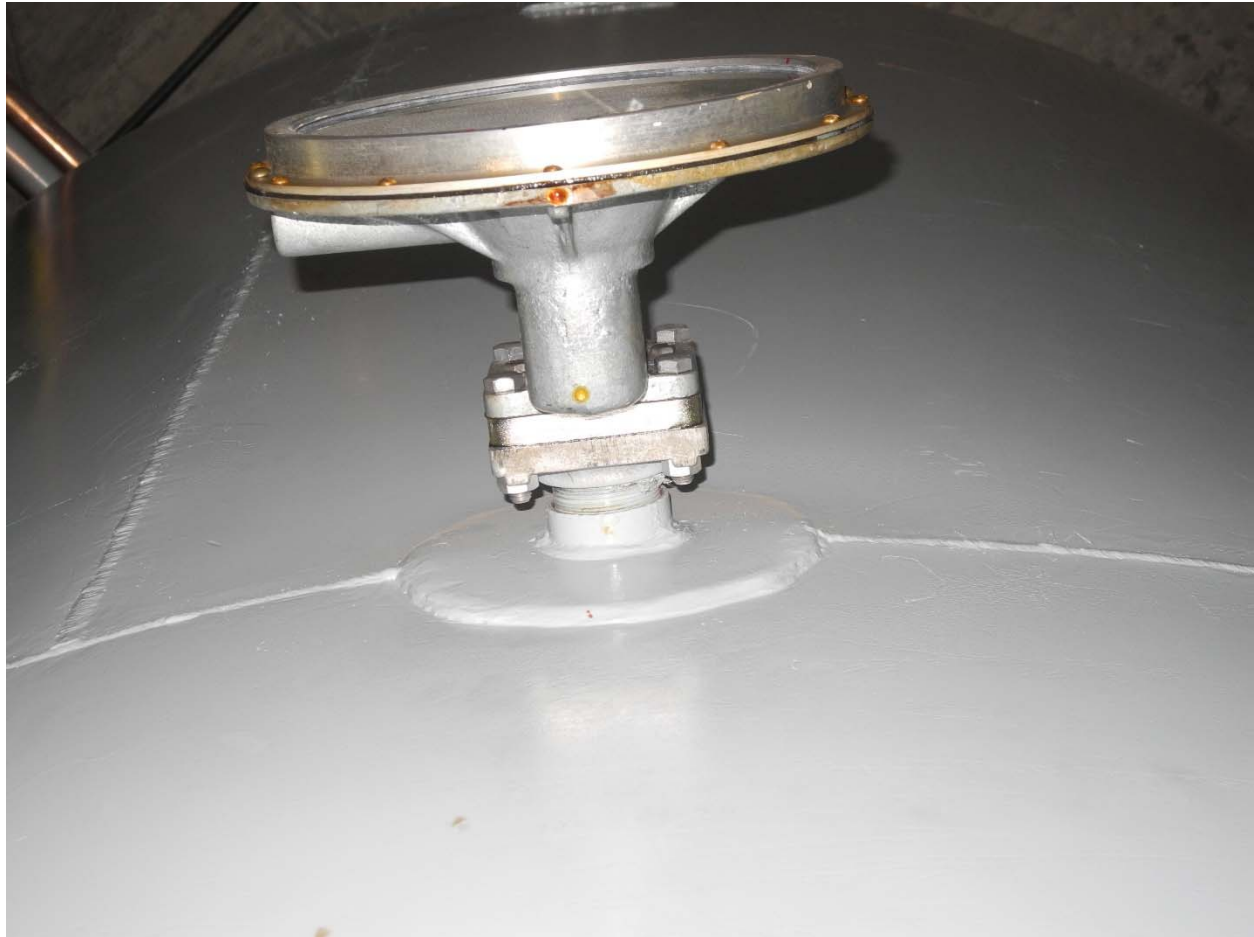
This photograph shows oil leaking through the gasket on a level indicating gage on one of the tanks. The dial level gages on each tank are leaking oil. These gages were not currently calibrated. These gages should be calibrated to verify operation and accuracy of the gages.

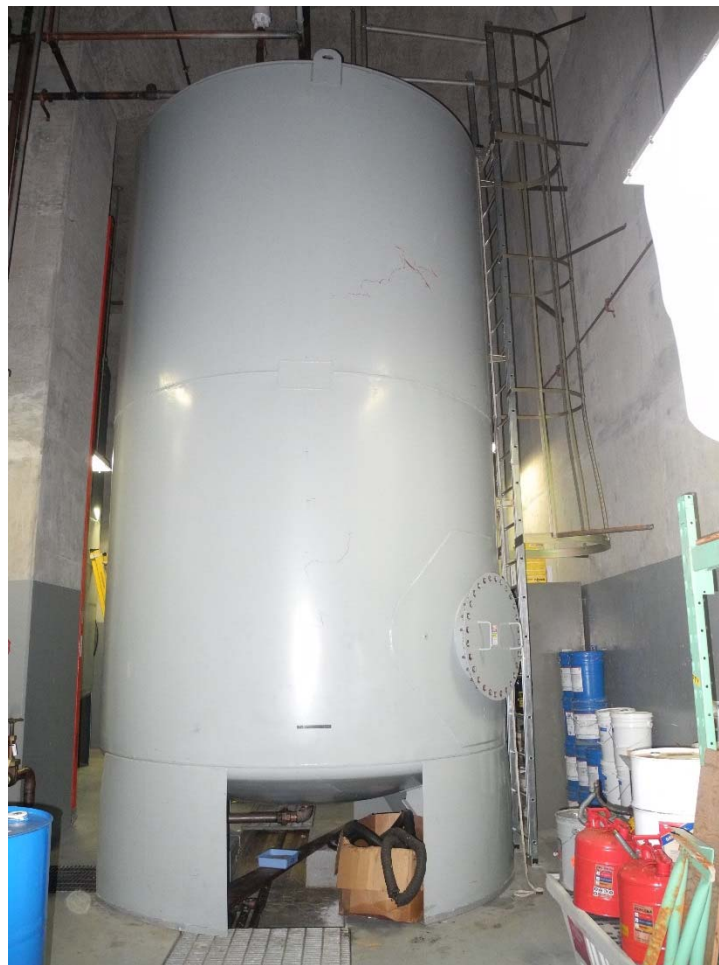
Tank No. 1, Clean Lube Oil, 10,000-Gallon Capacity

This is a 10,000-gallon capacity, single-walled oil storage tank.

The drawings specify the tank shell to be 0.25-inch and the head to be 0.32-inch thick. There was no severe corrosion found with UTT. The overall condition of the tank is good.

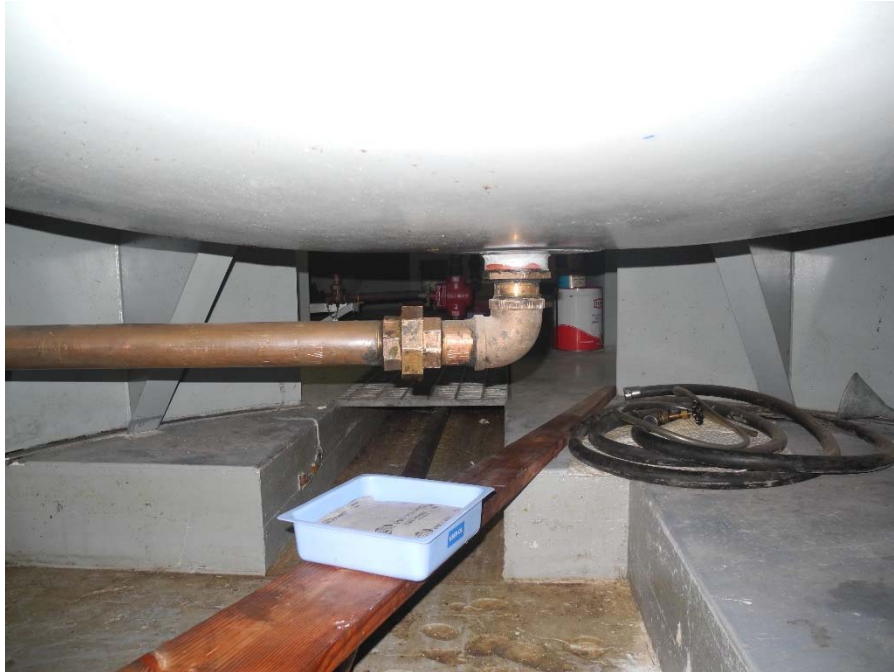
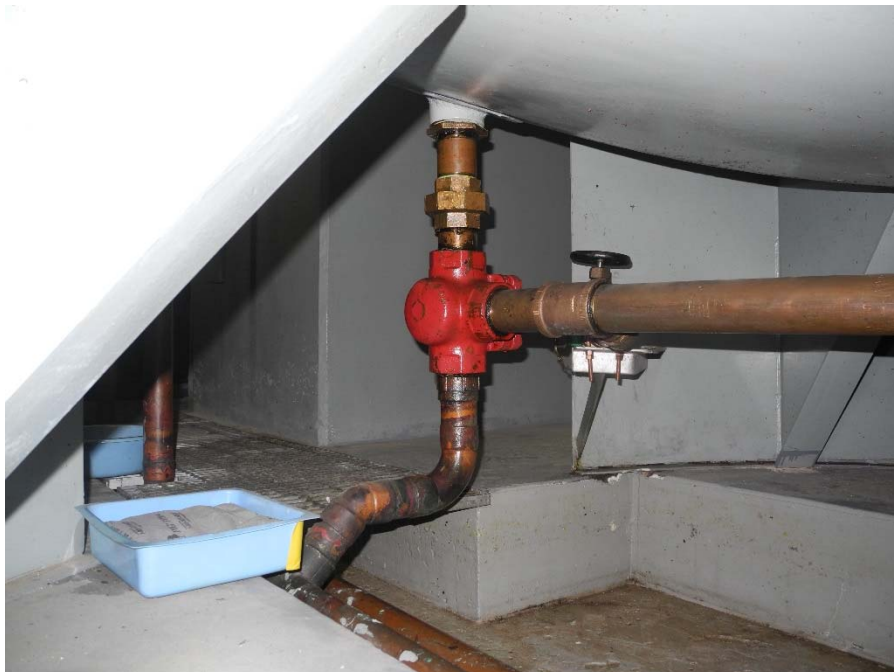
These photographs show some leaking threaded fittings on the bottom of the tank. These leaks should be fixed at a convenient time in the near future.

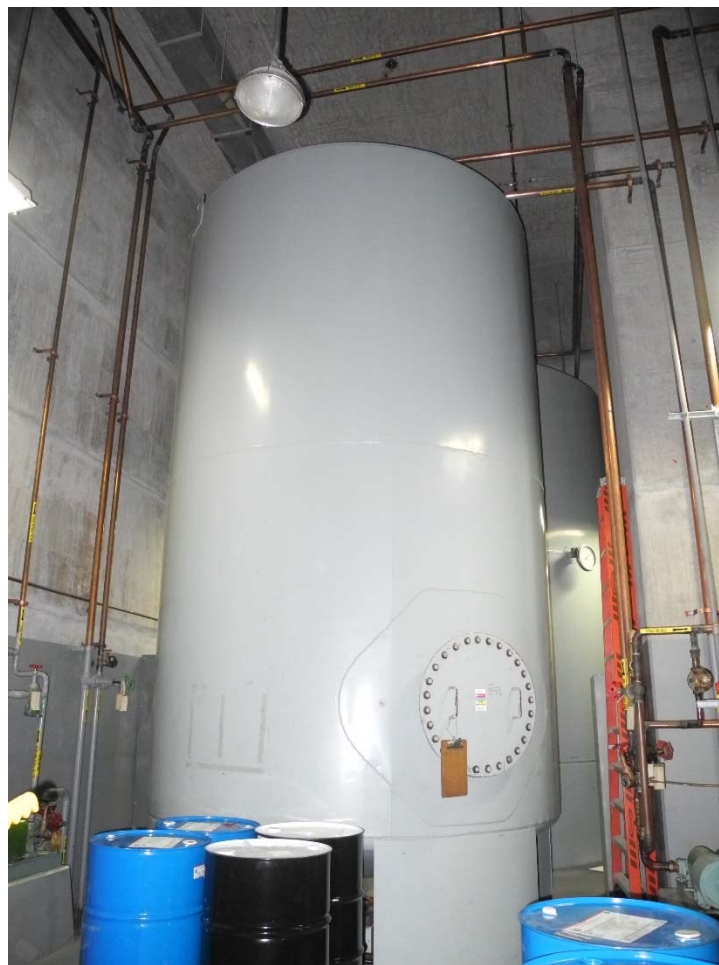
Tank No. 2, Dirty Lube Oil, 10,000-Gallon Capacity

This is a 10,000-gallon capacity, single-walled oil storage tank.

The drawings specify the tank shell to be 0.25-inch and the head to be 0.32-inch thick. There was no severe corrosion found with UTT. The overall condition of the tank is good.

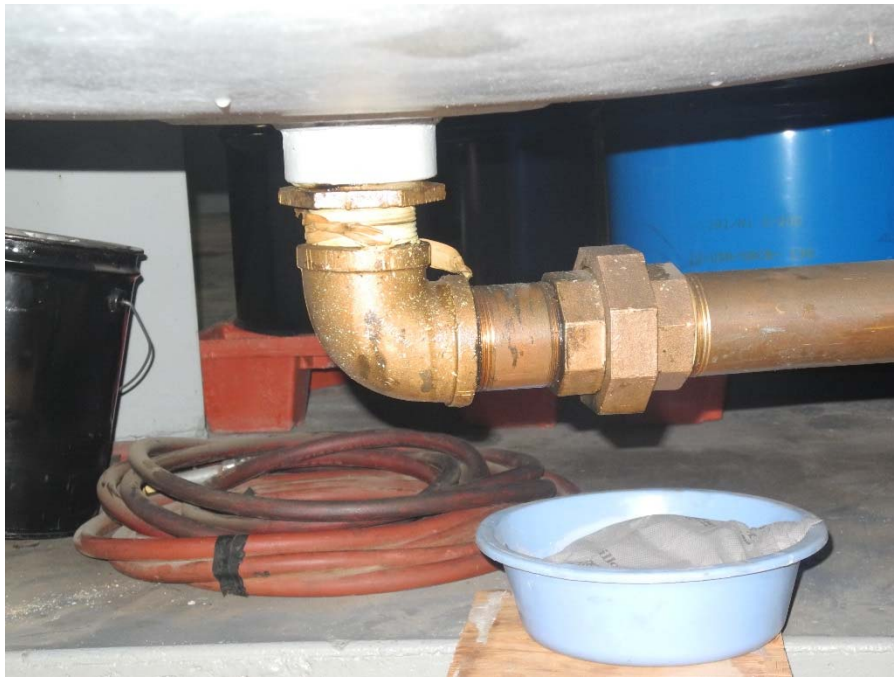
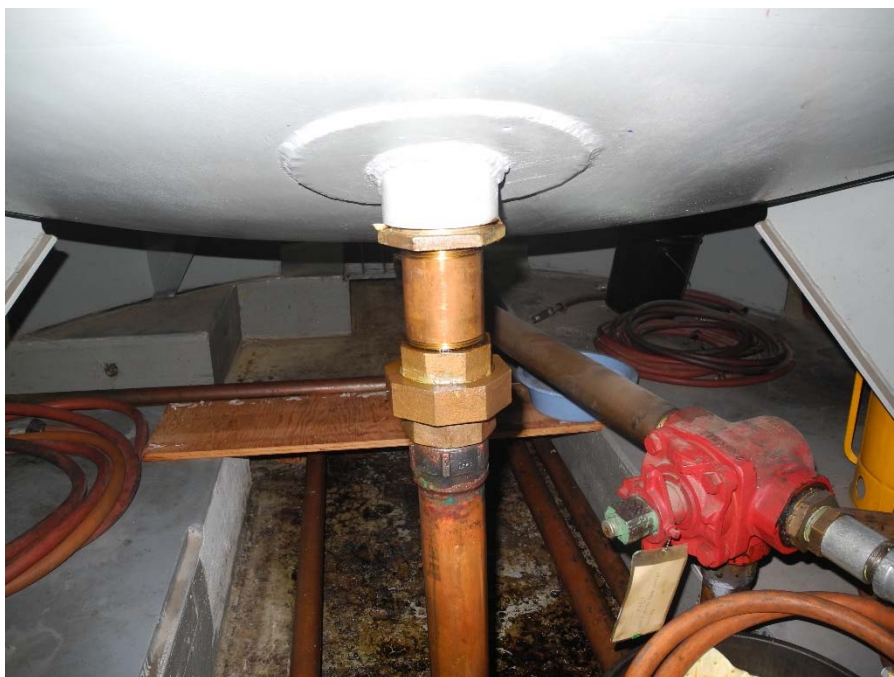
These photographs show some leaking threaded fittings on bottom of the tank. These leaks should be fixed at a convenient time in the near future.

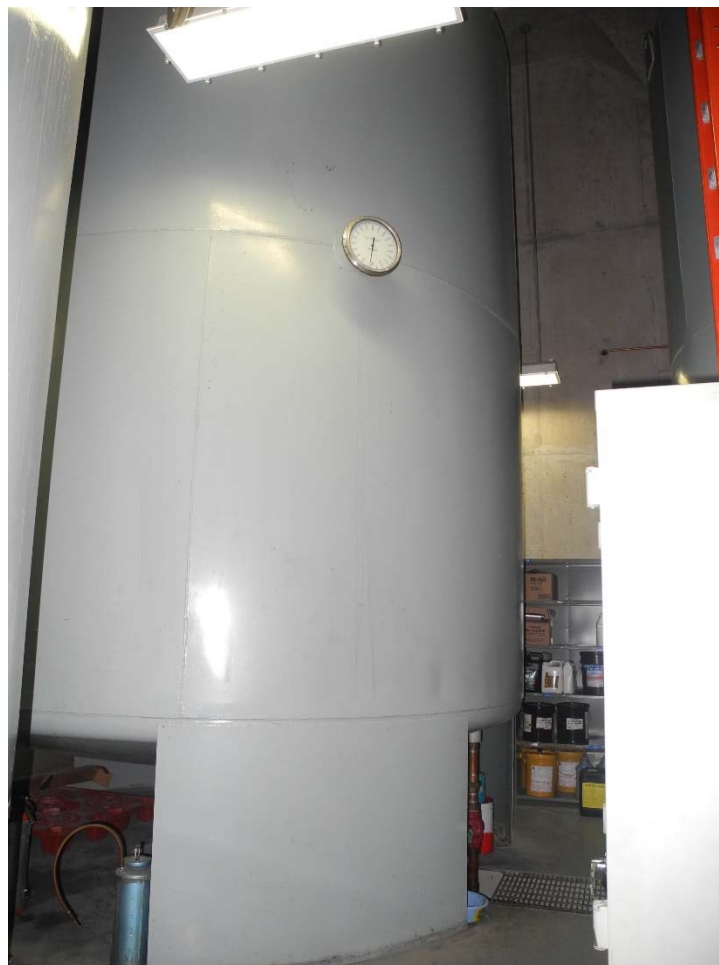
Tank No. 3, Clean Transformer Oil, 20,000-Gallon Capacity

This is a 20,000-gallon capacity, single-walled oil storage tank.

The drawings specify the tank shell to be 0.25-inch and the head to be 0.50-inch thick. There was no severe corrosion found with UTT. The overall condition of the tank is good.

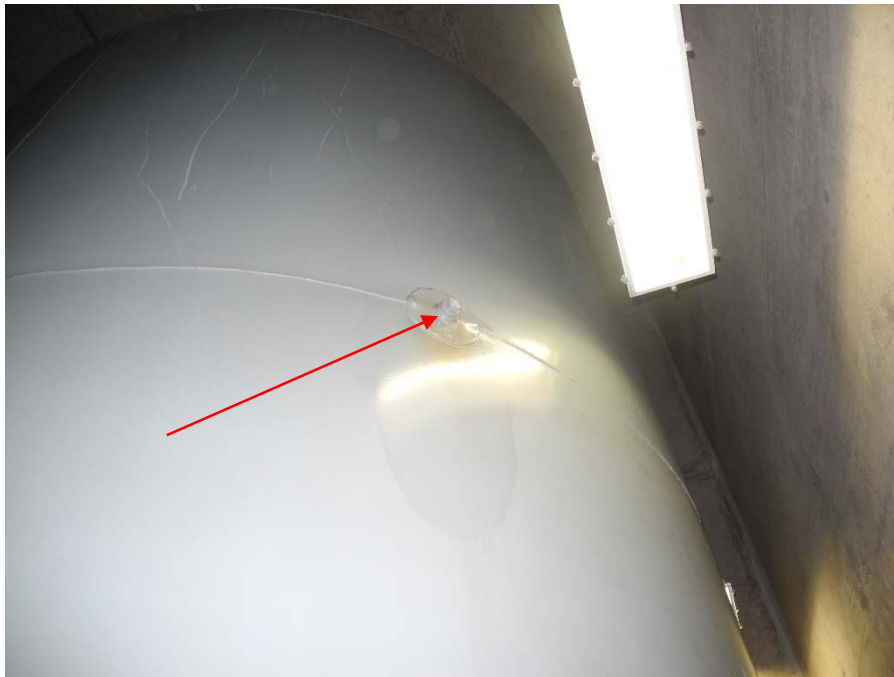
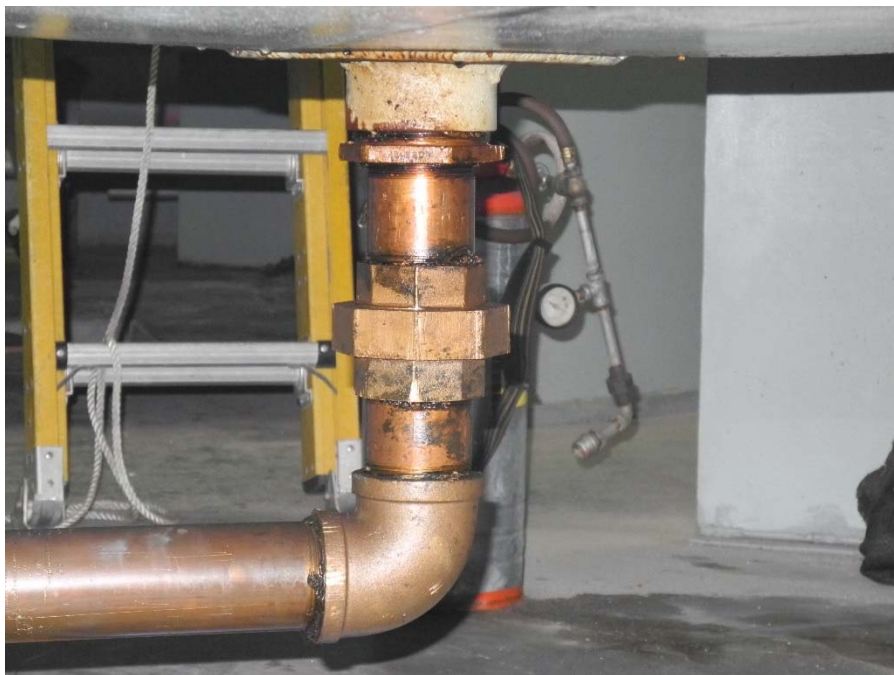
These photographs show some leaking threaded fittings on the tank. These leaks should be fixed at a convenient time in the near future.

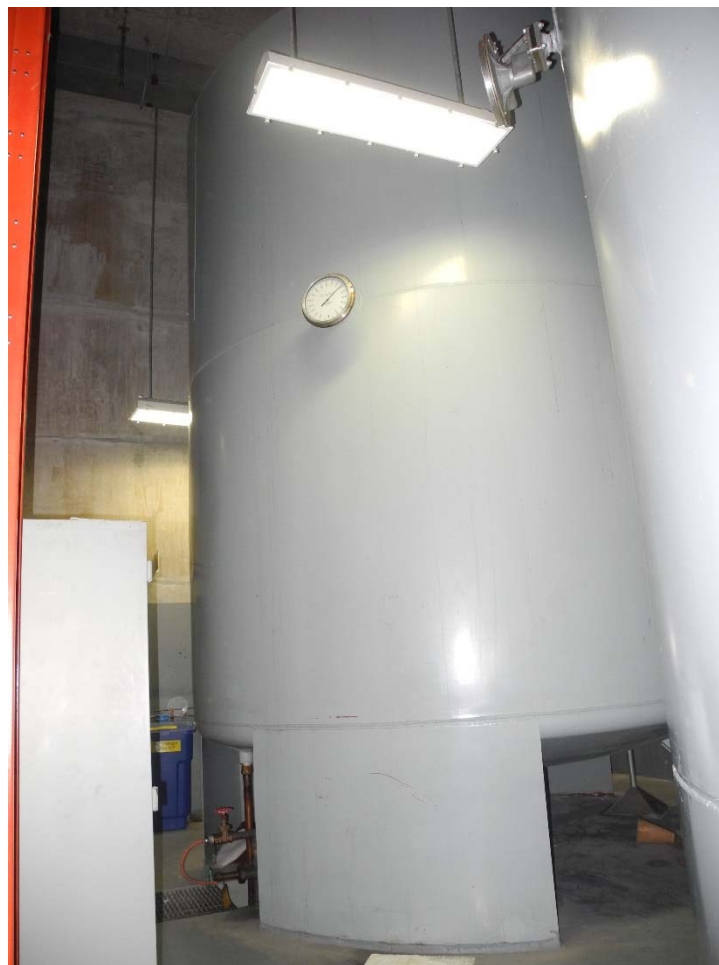
Tank No. 4, Dirty Transformer Oil, 20,000-Gallon Capacity

This is a 20,000-gallon capacity, single-walled oil storage tank.

The drawings specify the tank shell to be 0.25-inch and the head to be 0.50-inch thick. There was no severe corrosion found with UTT. The overall condition of the tank is good.

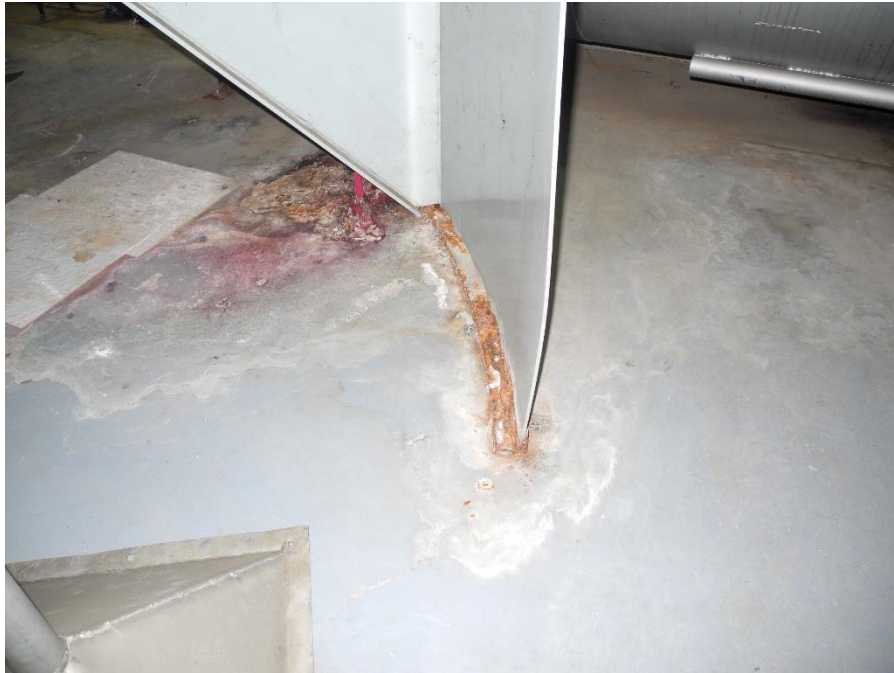
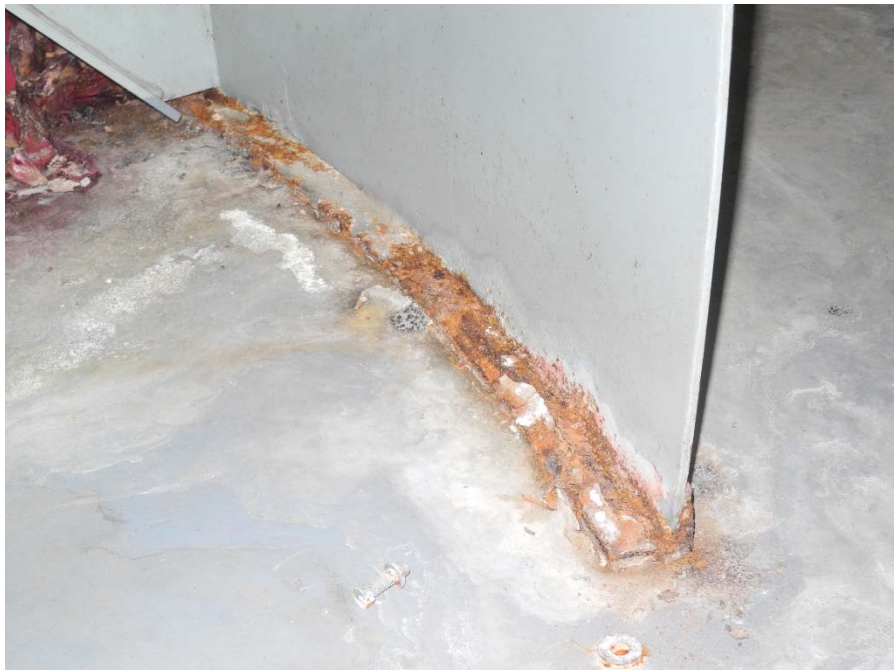
These photographs show the corrosion occurring at the tank support base angles. There is standing water in this location. The water should be diverted away from the tank support, the corrosion removed and the affected area re-coated.

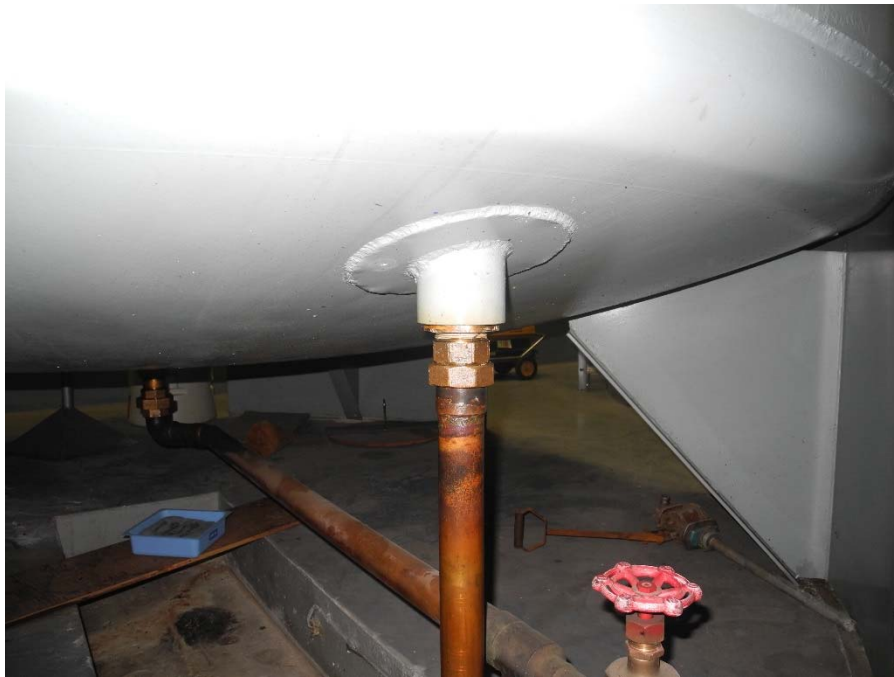
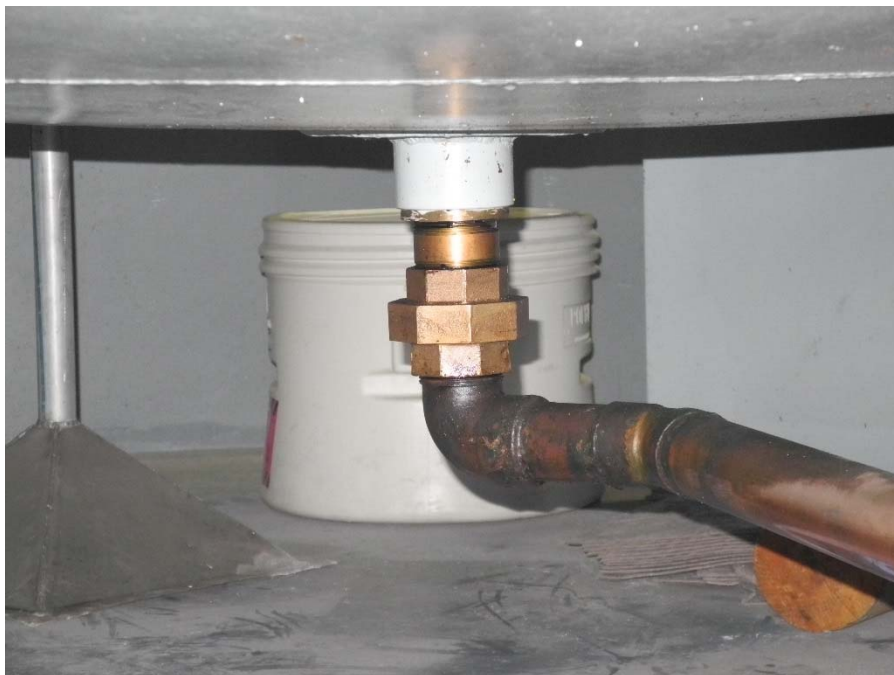
These photographs show some leaking threaded fittings on bottom of the tank. These leaks should be fixed at a convenient time in the near future.

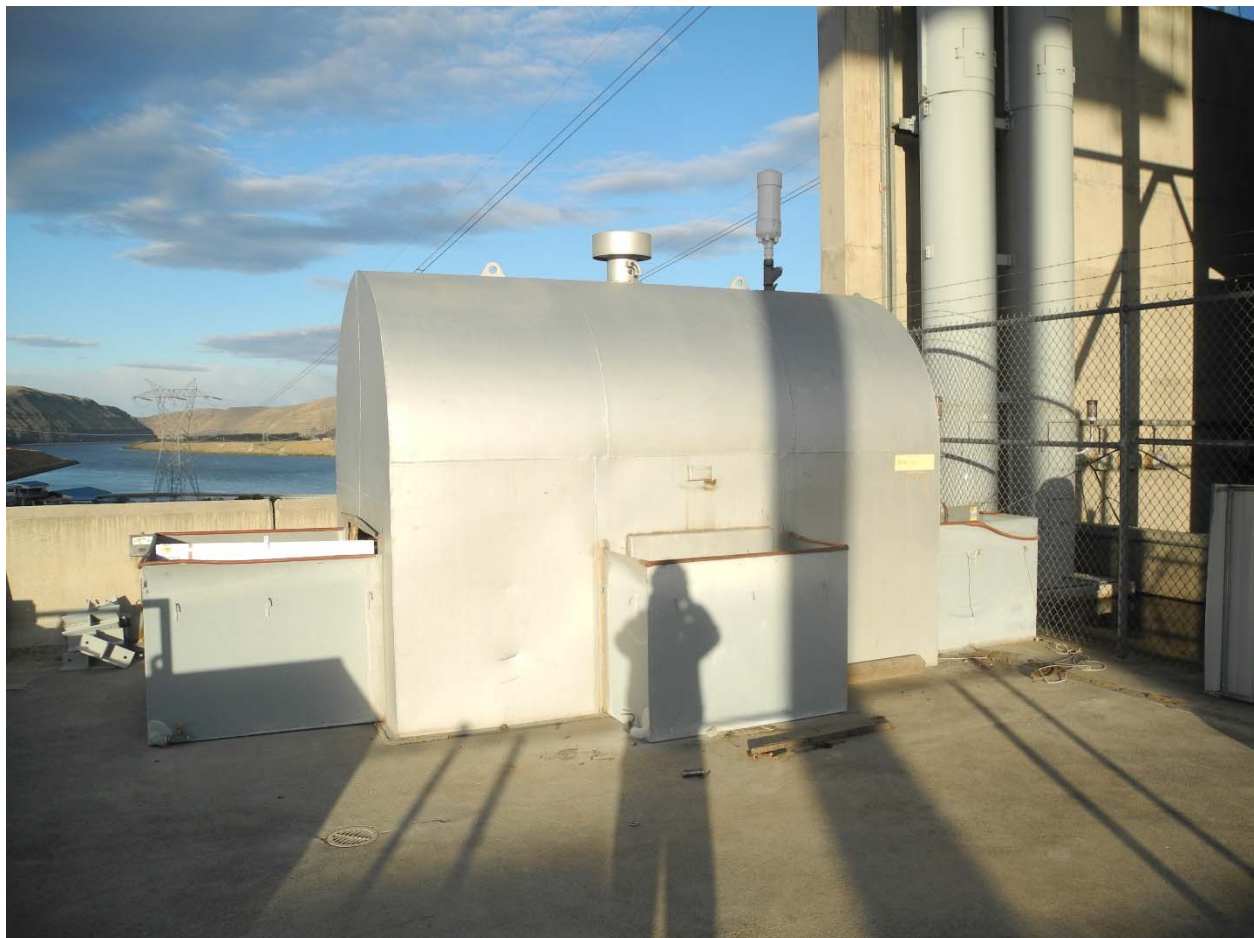
Head Gate Hydraulic Oil Tank, 1,200-Gallon Capacity (El 642')

This is a 1,200-gallon, single-walled storage tank without any secondary containment.

This tank is not grounded. In Steel Tank Institute R912 "Installation Instructions for Shop Fabricated Stationary Aboveground Storage Tanks for Flammable, Combustible Liquids" it states in 1.2 "For tank installations without cathodic corrosion protection, the tank should be grounded in accordance with applicable electrical and fire code standards."

There is not an NFPA placard that identifies the contents of the tank. An appropriate placard with the identification of the tank contents should be attached to the tank.

There was no severe corrosion found with UTT. The overall condition of the tank is good.

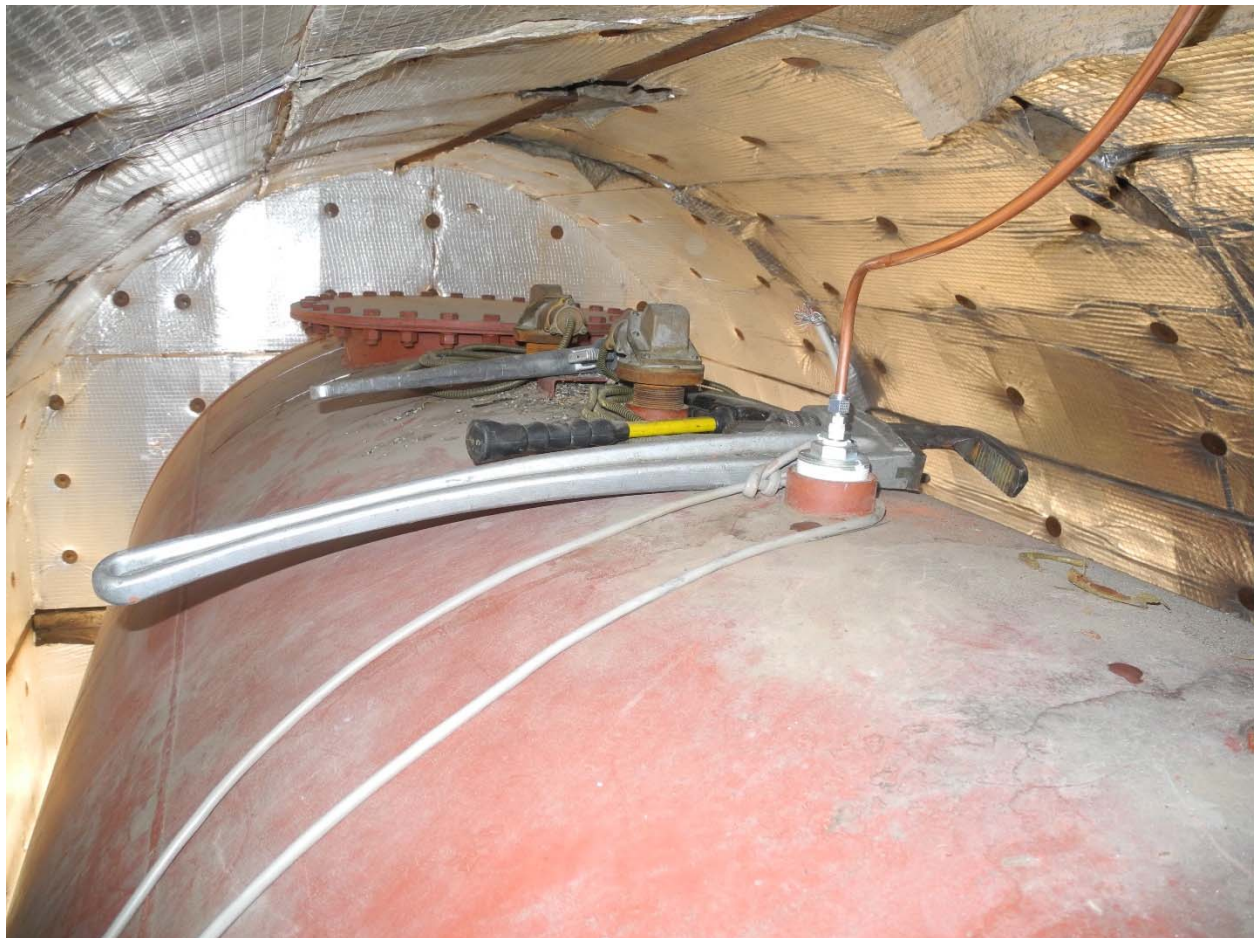
There is not an emergency relief vent. An emergency relief vent capable of venting 125,000 cubic feet per hour should be installed. It may be possible to use the manhole as an emergency relief vent by installing longer bolts.

This tank should be vented to atmosphere.

There is not an overflow for this tank. Overflow piping and reservoir should be installed in order to account for an overflow condition. This is a category 3 storage tank that has no secondary containment.

The leak test of this tank was performed by pressurizing the tank to 1.5 psi with nitrogen gas. The pressure was maintained as leak solution was applied to all the welds on the tank exterior. No leaks were detected.

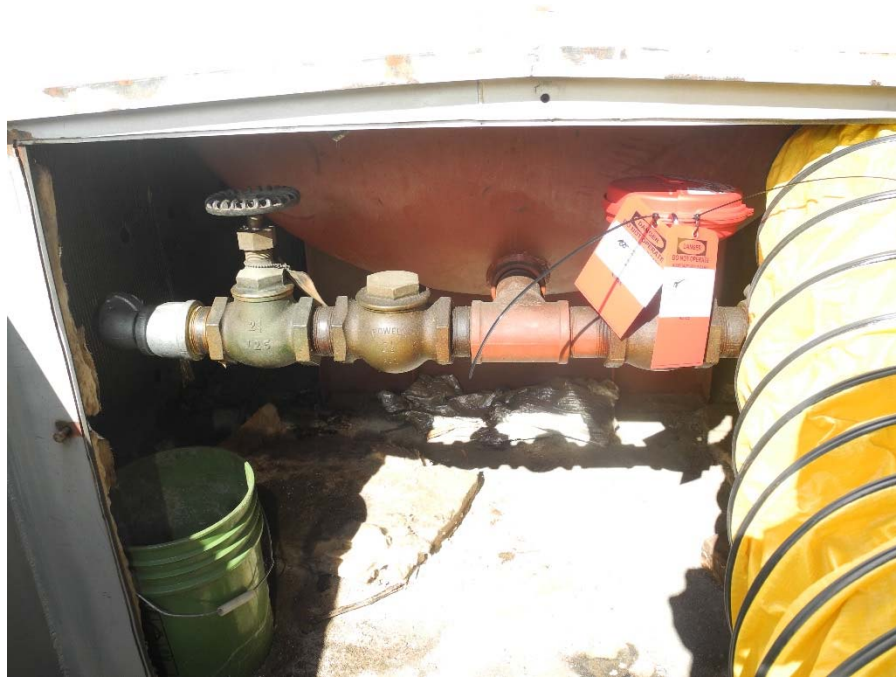
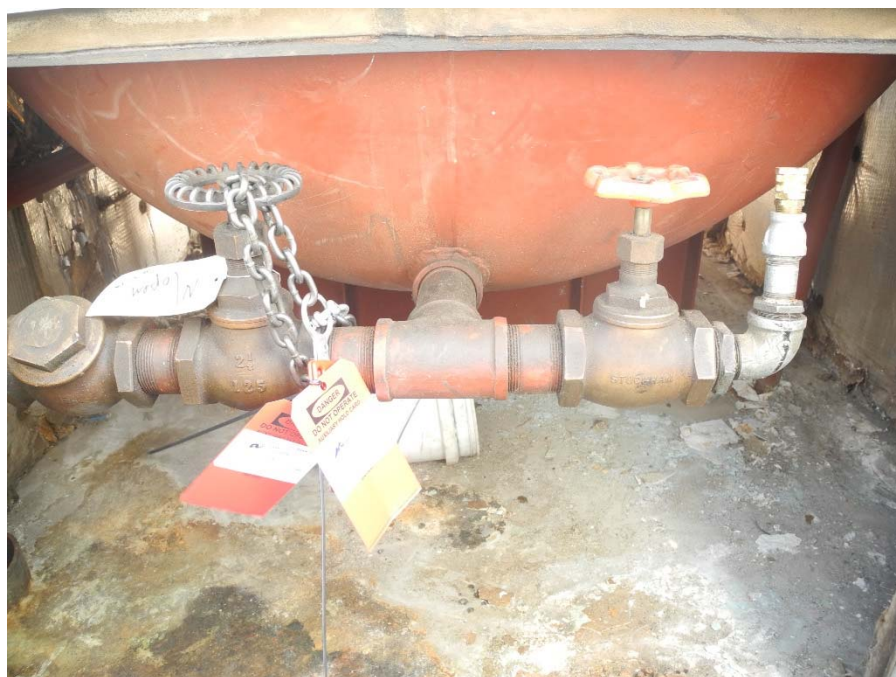
These photographs show some leaking threaded fittings on each end of the tank. These leaks should be fixed at a convenient time in the near future.
